## **MEMO**

Date:	February 11, 2016
Project No.	C150132.00
То:	Kenneth Roller, Dominion
From:	Scott Quinlan, GAI Consultants, Inc.
cc:	John Klamut, GAI Consultants, Inc.
Subject:	Possum Point Outfall 010

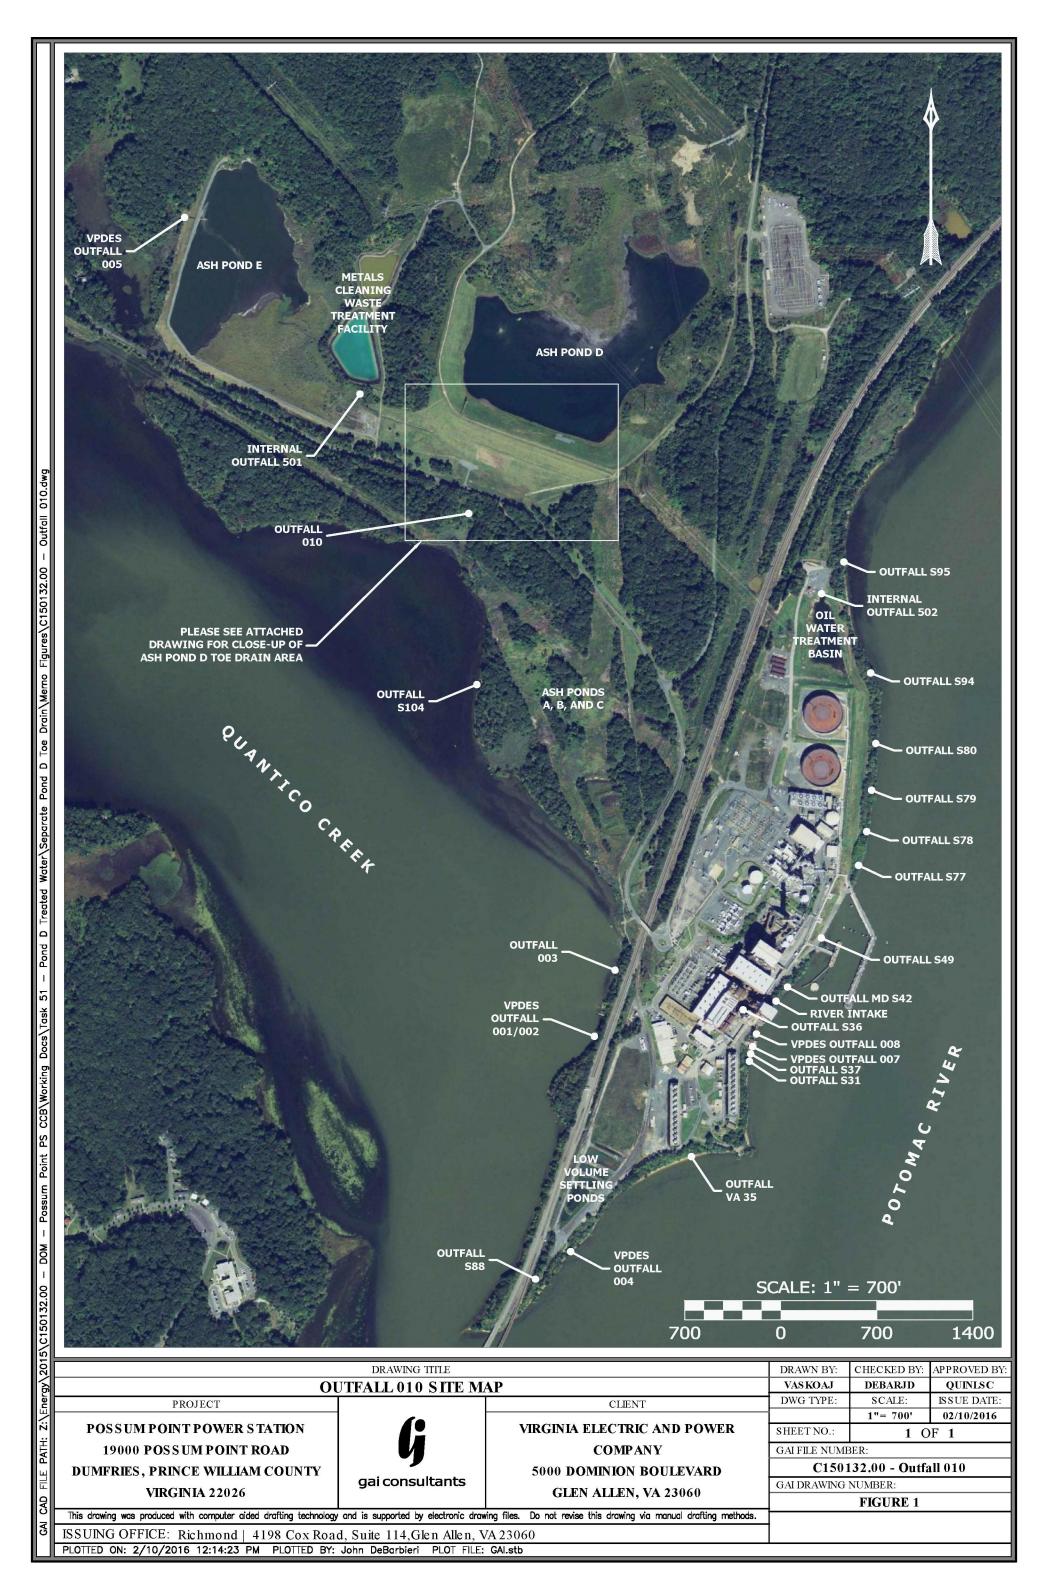
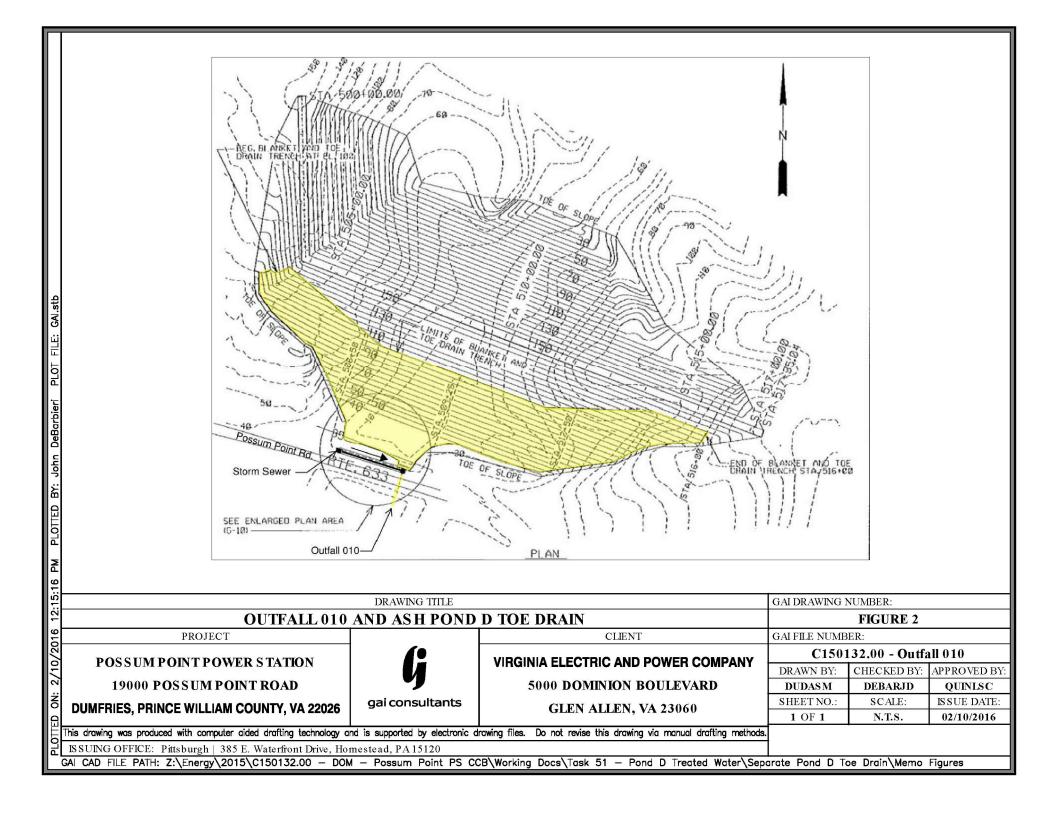
Pursuant to our meeting with the Virginia Department of Environmental Quality (VaDEQ) on Wednesday, February 3rd, 2016, this serves as an overview of the plan for eliminating the discharge from Outfall 010. Outfall 010 is located south of Pond D across Possum Point Road (see attached Figures 1 and 2).

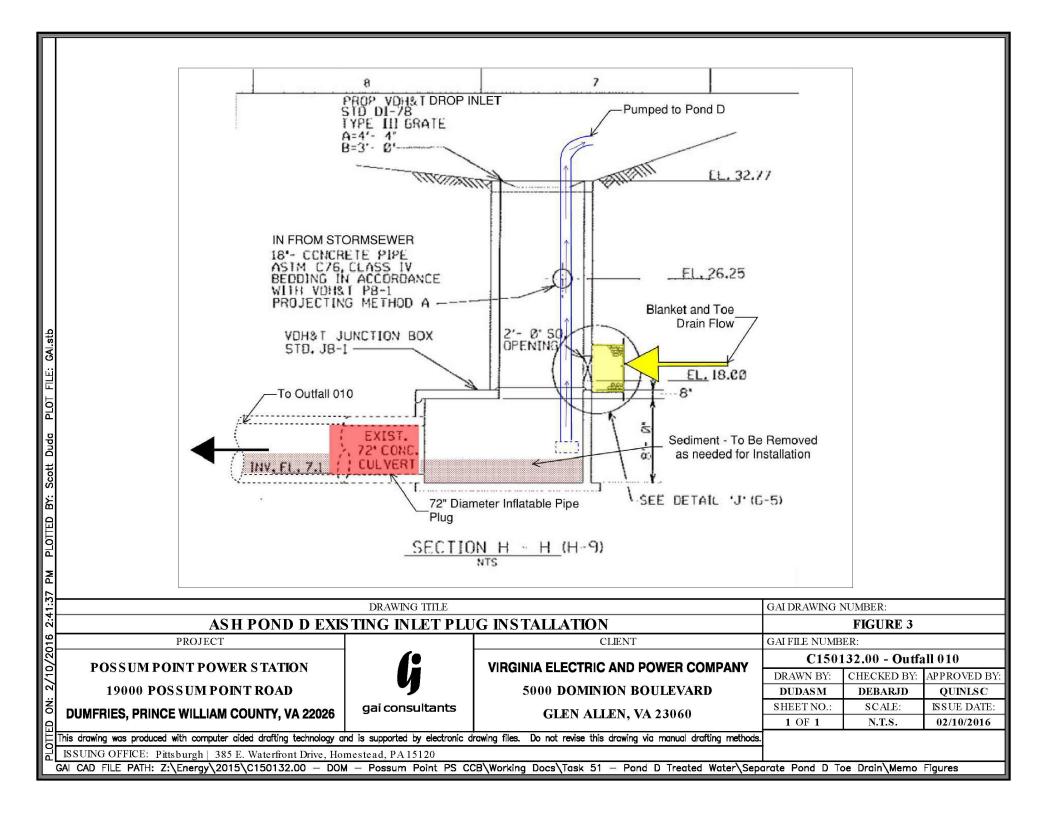
The interim solution includes the installation of dual submersible pumps in the existing inlet north of Possum Point Road (Refer to Figure 3). This inlet is upstream of the 72" reinforced concrete culvert that crosses the road and of which the downstream discharge is Outfall 010. The 72" culvert will be plugged on the upstream and downstream ends. Additional earth fill will be added at the outfall to contain the plug. A block and mortar bulkhead may be added prior to the upstream plug at the existing inlet at a later date. Thus, stormwater, and the Pond D Toe Drain will be isolated and collected in the existing inlet and redirected (pumped) to Pond D. This interim solution will eliminate the discharge from Outfall 010 since all storm and toe drain waters will be sent to Pond D. The waters will then be treated and discharged to Internal Outfall 503 upon approval and commissioning of the treatment system.
